Repair preparedness of submarine cables in Statnett

SubOps 2023

Haugesund 9-10 August 2023, Ole Petter Hobbestad

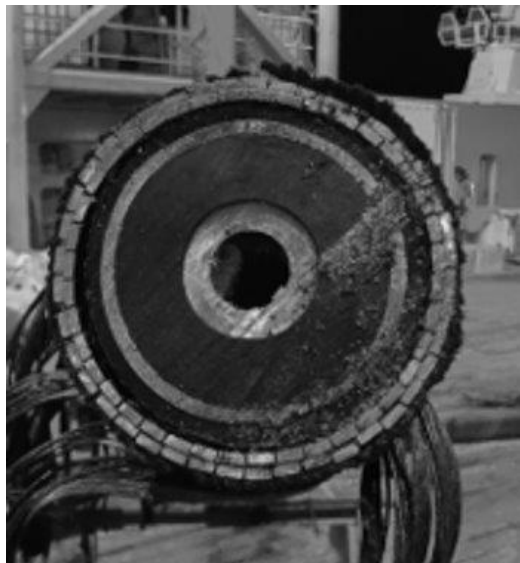
Mass impregnated (MIND)

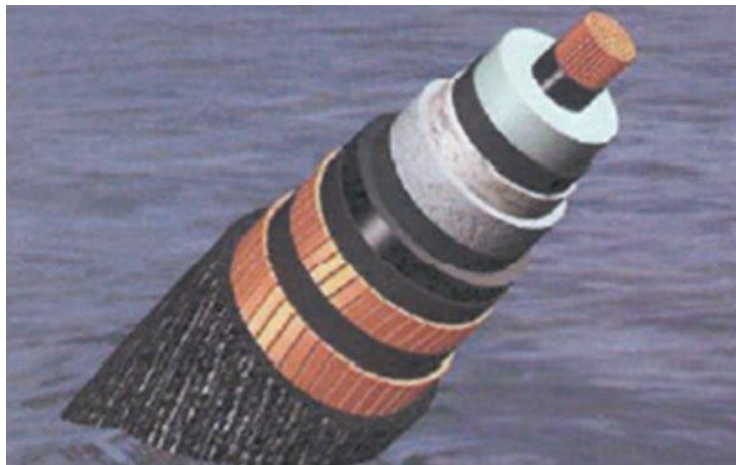
1 x PEX

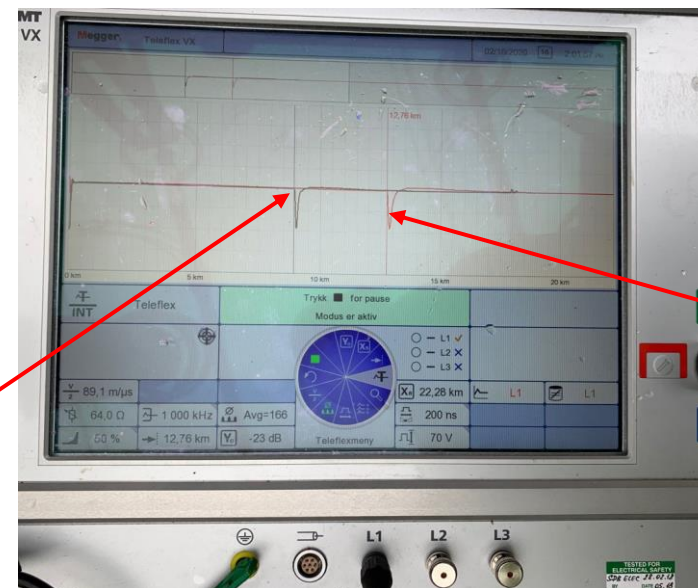
Fault finding. First steps

- TDR, Time Domain Reflectometry
- OTDR (Optical Time Domain Reflectometry)
- Fault at 3 of 9 cables (Oslofjord)

Fault ~9km

End reflection
from previous
measurements

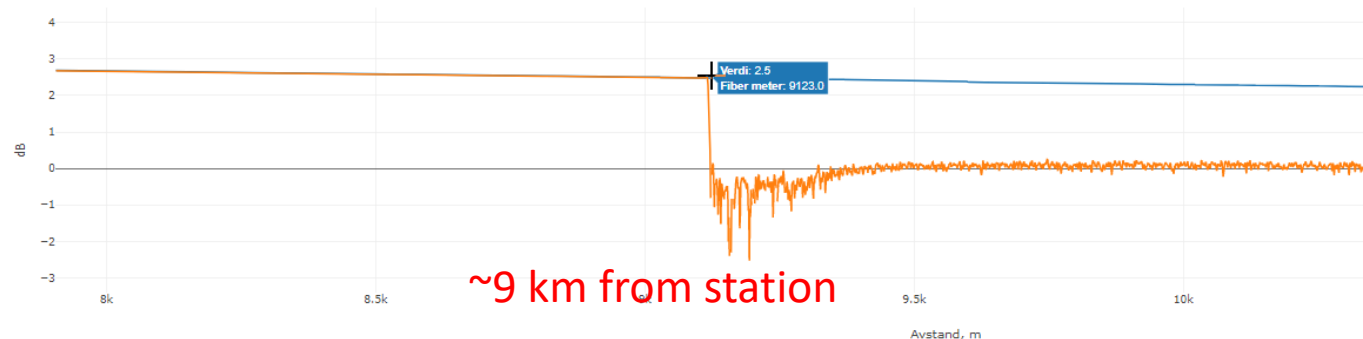
Profiltype: OTDR Kabel: K6 Profil tidsstempel: < 2020-05-04 01:14:19 > Legg til graf Tilbakestill graf

Sammenligningsplott

OTDR before fault

OTDR after fault

~9 km from station

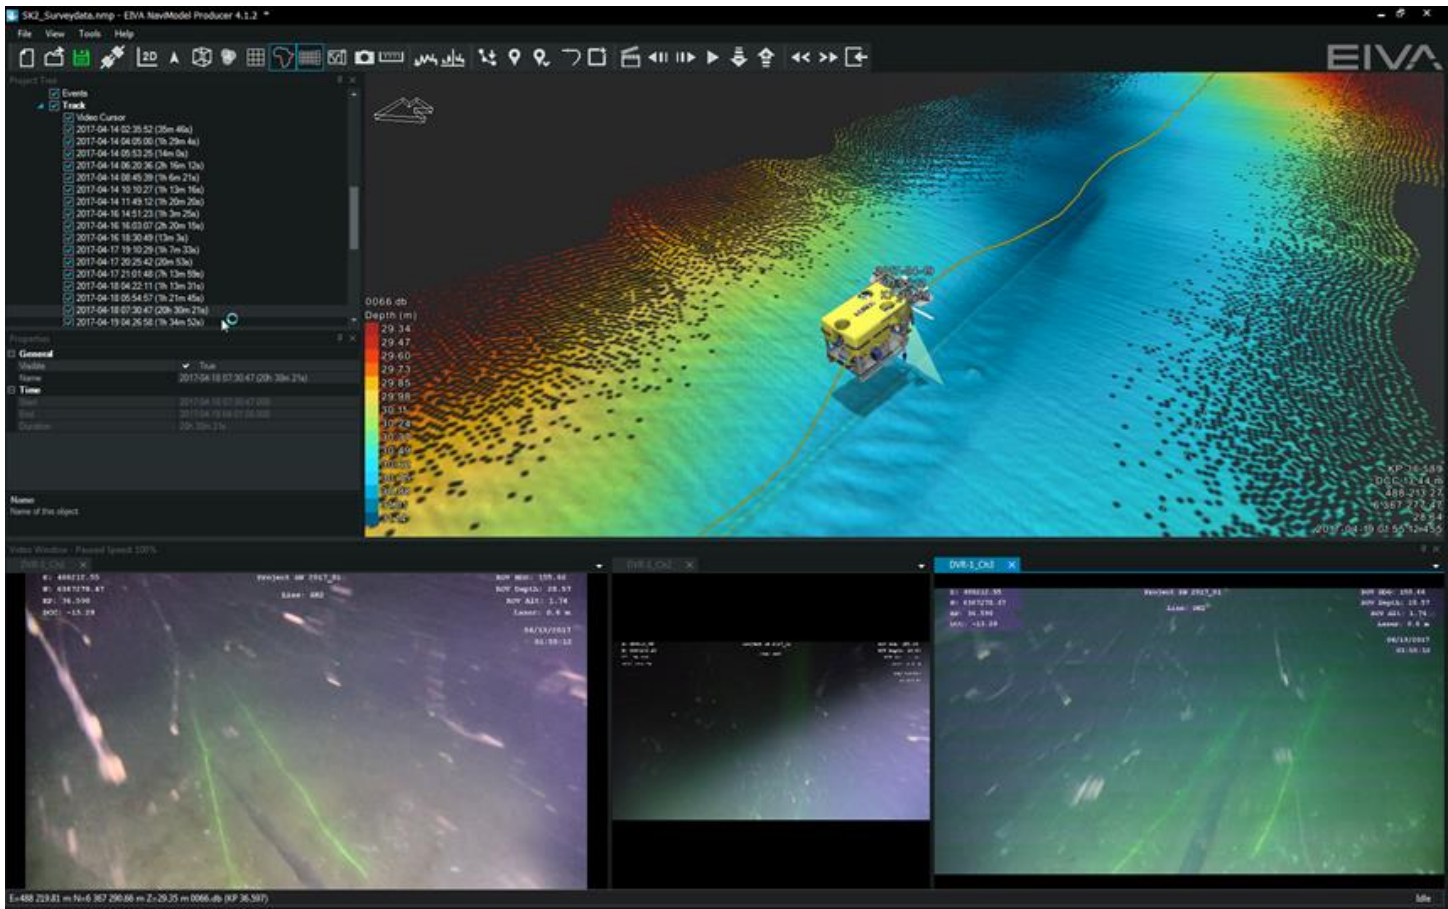
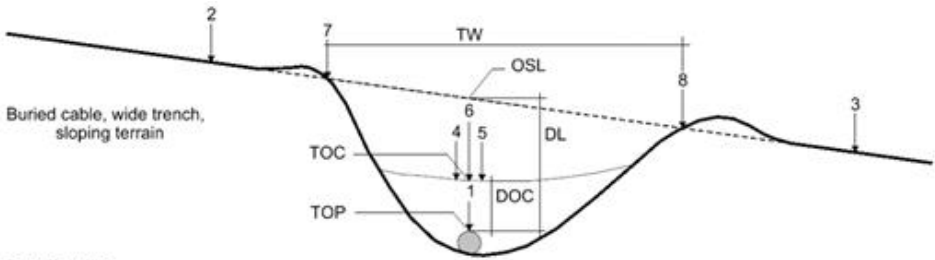
Inspection, Depth of burial / Level of protection

DEFINITIONS:
OSL Original Seabed Level: Depth to a point on a line between Flag 2 & 3 horizontally positioned at Flag 1 from vertical reference level
DL Depth of Lowering: Vertical distance between Flag 1 and OSL
DOC Depth of Cover: Vertical distance between Flag 6 and Flag 1. Positive if cable is buried, negative if exposed
TW Trench Width: Horizontal distance between Flag 7 & 8
TOC Top of Cover: Depth to Flag 6 from vertical reference level
TOP Top of Product: Depth to Flag 1 from vertical reference level

Cable in rockberm
Flag 7 = Left "shoulder" of rockberm
Flag 8 = Right "shoulder" of rockberm

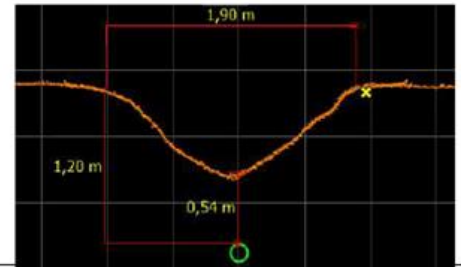
- **Explanation:**
- Depth of Lowering (DOL) = 1.20 m
- Depth of Cover (DOC) = 0.54 m
- Trench Width = 1.90 m
- SRI = Subsea Rock Installation

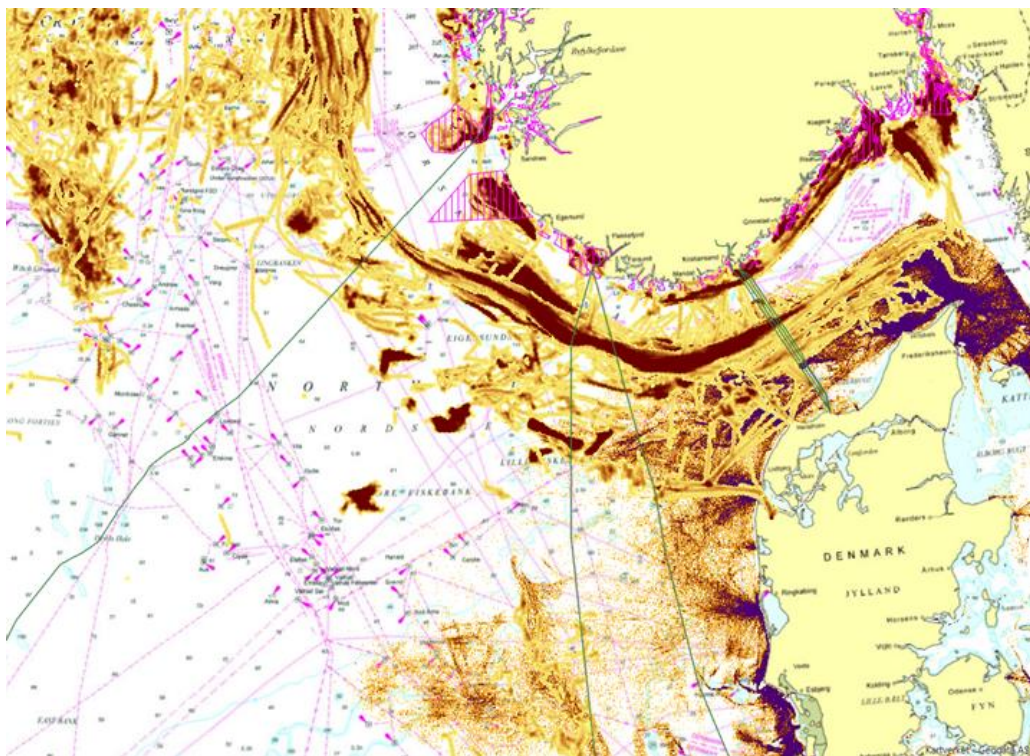
Maritime activity monitoring. Risk assesment

- Om Innhold Tegnforklaring
- Innhold
- ☒ Cables - As built
 - ☐ STBDS Vessels with speed less than 1 knot
 - ☒ STBDS Fishing Vessels in Buffer
 - ☐ STBDS Vessels in Cable Buffers
 - ☐ Seabed Features
 - ☐ Seabed Protection
 - ☐ Seabed Tracks
 - ☐ Seabed ProductEvent
 - ☐ SEABED SSS Inland
 - ☐ SEABED SSS Utland
 - ☐ SEABED DTM Inland
 - ☐ SEABED DTM Utland
 - ☐ SEABED SHA Inland
 - ☐ SEABED TCH Utland
 - ☐ AIS Density Plot fishing vessels 2021
 - ☒ GeocacheKyst
 - ☐ Fiskeridirektoratet: Kystnære fiskeridata
 - ☐ Kystverket WMS - kart
 - ☐ ENC Kystkartverket
 - ☒ Graatone Terreng Vektor
 - ☐ Graatone Terreng Vektor

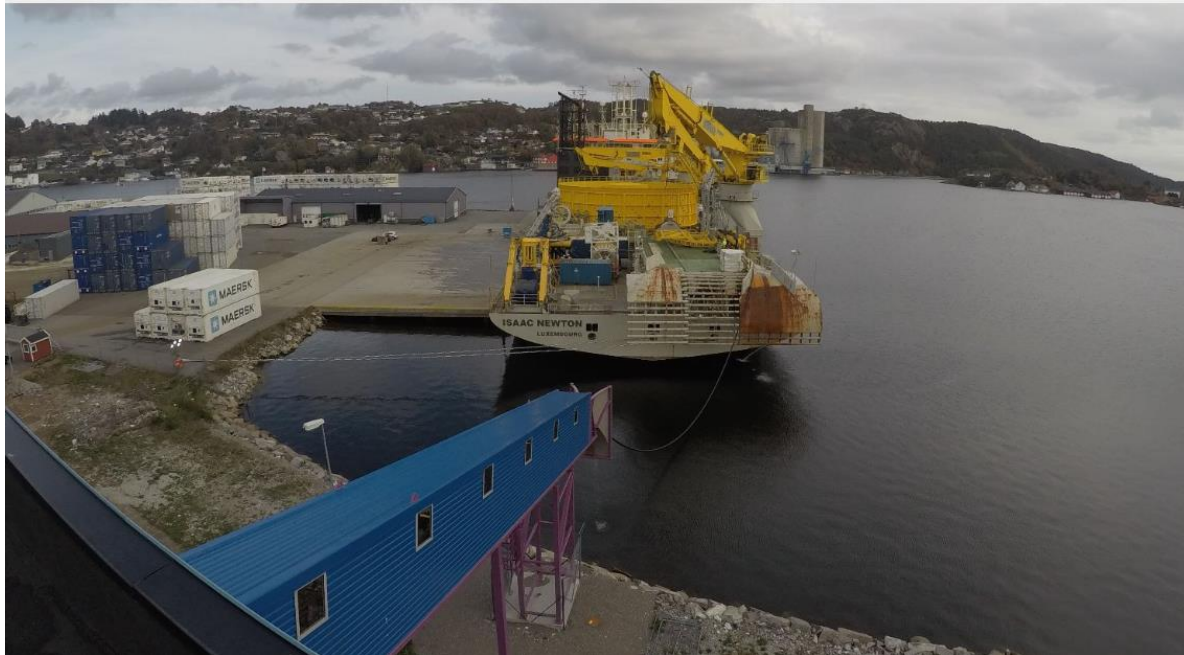
Cable storages

- Three turntables, capacity 8000 ton and 2 x 1200 ton
- Direct access to ISPS quay, vessel can be positioned long side while cable is loaded over the stern
